TECHNICAL INFORMATION

LOW-VOLTAGE PERFORMANCE OF MULTILAYER CERAMIC CAPACITORS

N. H. Chan and B. S. Rawal
AVX Ceramics
P.O. Box 867
Myrtle Beach, SC 29577

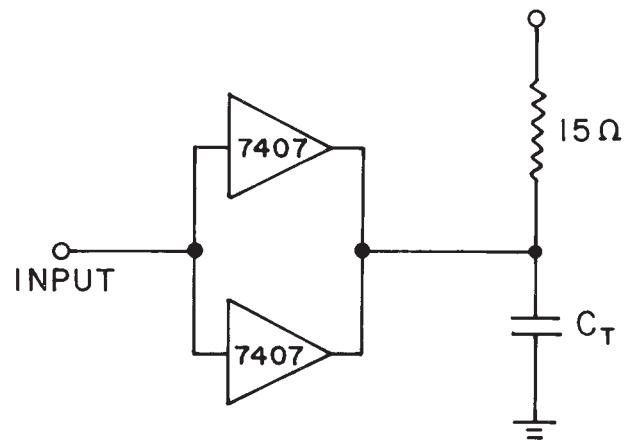
Figure 1(a). Low-Voltage, High-Current Pulse Test Circuit

A square-wave generator was employed to trigger the switches. The pulse width used was 100-ns with a 10-ns rise time at a frequency of 1 MHz. As an example, voltage across a 0.1 μF test capacitor was about 4 V and current was about 0.75 A. (See waveforms in Figure 1(b).) Each capacitor was subjected to about 3.6 billion pulses for the test (1 hour on test).

In order to simulate a decoupling application, the circuit shown in Figure 1(a) was used to apply low-voltage, high-current pulses to another set of capacitors. Several groups of X7R/BX and Z5U dielectric capacitors were studied using this procedure. Several hundred parts were tested in each group, after samples from each group were examined to assure the absence of physical flaws, such as cracks and voids.

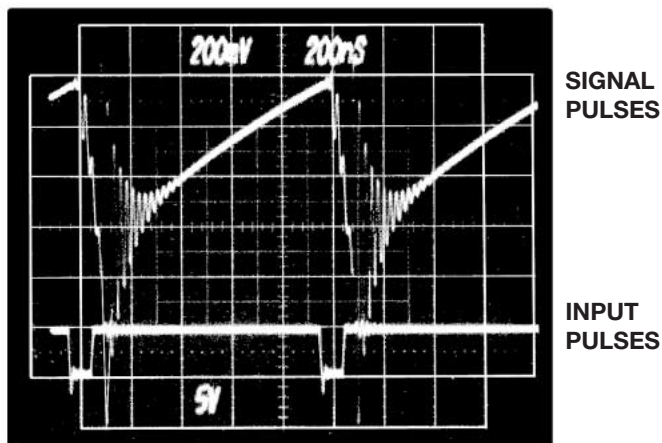
Figure 1(b). A typical test signal from the Current-Pulse Test (example for 0.1 μF capacitor)

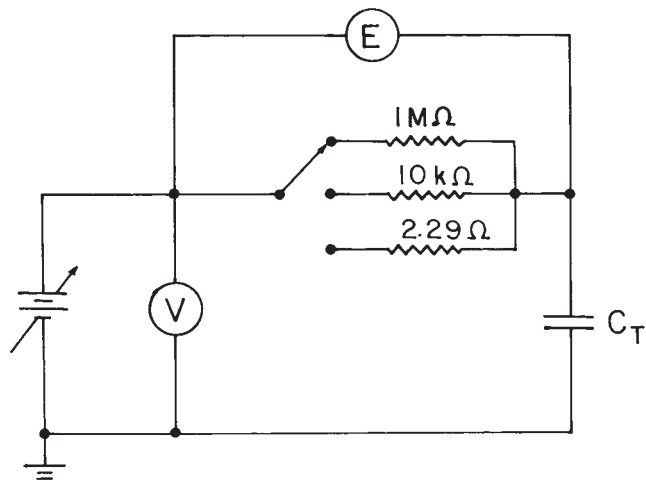
A two-minute IR measurement at 2 VDC was performed for each capacitor before and after the current-pulse test. An electrometer was used and the output was applied to a strip-chart recorder (Figure 2). These parts were then subjected to a 2-minute IR measurement at 50 VDC and another two-minute IR measurement at 2 VDC. The purpose of these measurements was to first study any possible degradation of IR (and therefore the intrinsic behavior of the capacitor) due to the current-pulse test, and then to compare the low-voltage IR to the IR at the rated voltage of the capacitor.

Figure 2. Test Circuit for IR and I-V Measurements

The I-V characteristics of some of the 40 unstable capacitors mentioned above and parts from other control groups showing variations in IR were determined using the circuit in Figure 2. The selectable series resistors provide the signal current and limit current flow should capacitor breakdown occur during the voltage increment.

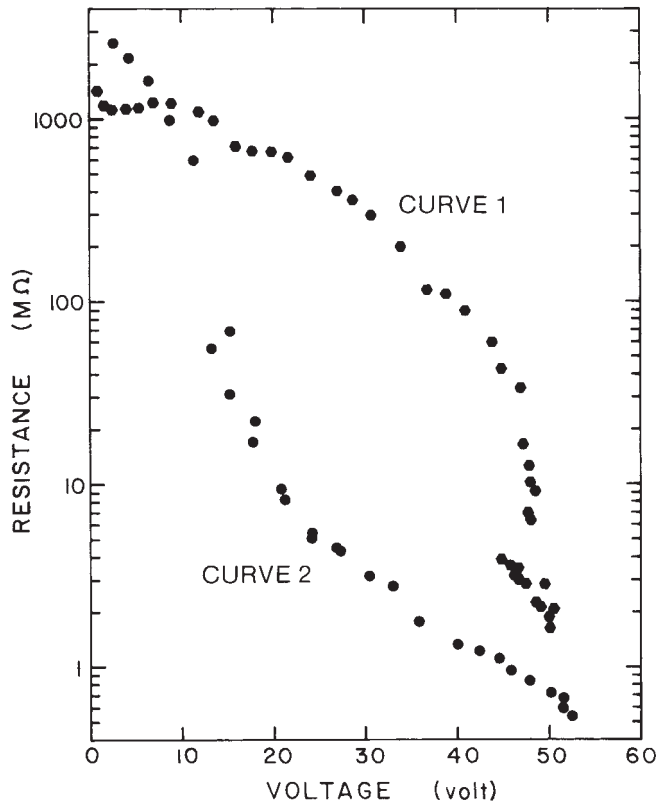
As an example, curve 1 in Figure 3 shows that IR decreases by as much as three orders of magnitude with increase of voltage. The most rapid degradation of more than two orders of magnitude occurred between 35 and 50 VDC again indicating the greater effect of higher voltages.

Figure 3. Variation of IR as a Function of Applied Voltage

Next, the voltage was increased to 53 volts and then reduced to zero. When the IR measurements were carried out again, curve 2 in Figure 3 results. This shows the higher voltage did more damage to the IR than the lower voltage. For these capacitors, IR degradation in the 0 to 5 VDC range was minimal, if any. (The ohmic heat dissipation is less than 1 nW at 1 V and 5 mW at 53 V.)

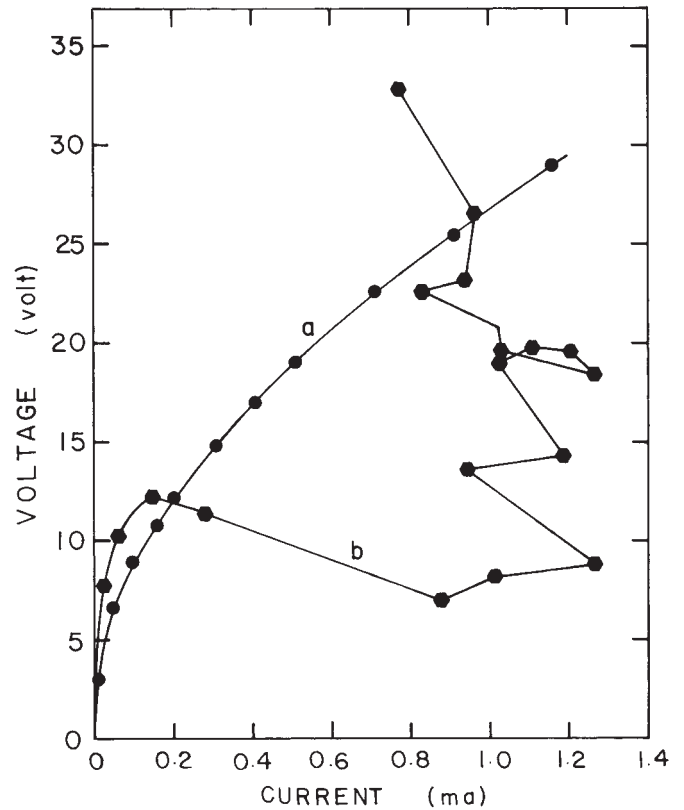
The I-V characteristics of two low-IR capacitors are shown in Figure 4. Curve (a) shows the non-ohmic behavior found in various parts with the approximate relationship:

$$I \propto V^n, \text{ where } 1 < n \leq 4.$$

In this particular case, the curve can be described by $I \approx 1.4 V^2 (\mu A)$. Curve (b) shows the unstable IR behavior where the behavior is unpredictable.

Figure 4. Two Typical I-V Characteristics of Low IR Parts with Physical Flaws

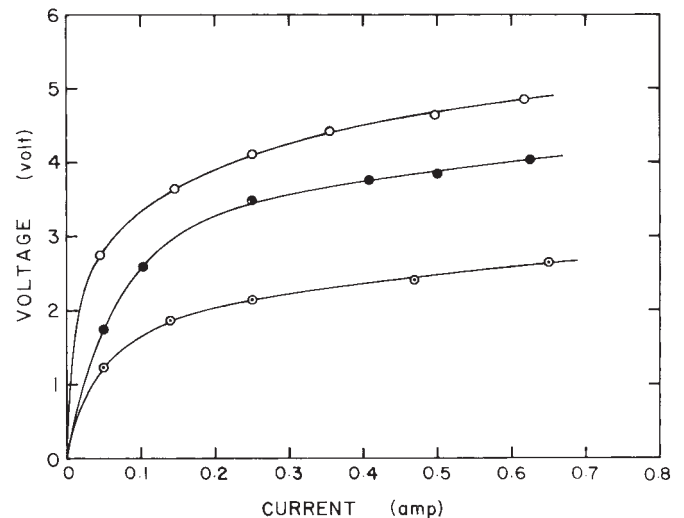
With repeated cycling, the IR is reduced further by several orders of magnitude due to the voltage degradation. As an example, Figure 5 shows typical I-V characteristic curves for three such components. Experimental data shows that about 10 watts are required for a capacitor to heat up and trigger thermal runaway failure. In a low-voltage, high-impedance application, where the current is less than 1 mA, the circuit does not have the capability to maintain this power level. In a low-impedance circuit, on the other hand, there is no current limitation to stop the heating process once it begins and thermal runaway can result. However, this mechanism is not unique to the low-voltage performance; in fact, it has already been shown that higher voltages actually do more damage.

Figure 5. I-V Characteristics of Three Control Parts with Their IR Degraded by Voltage
