TECHNICAL INFORMATION

REVERSE VOLTAGE BEHAVIOR OF SOLID TANTALUM CAPACITORS

by
Ian Bishop & John Gill
AVX Ltd.,
Paignton, England

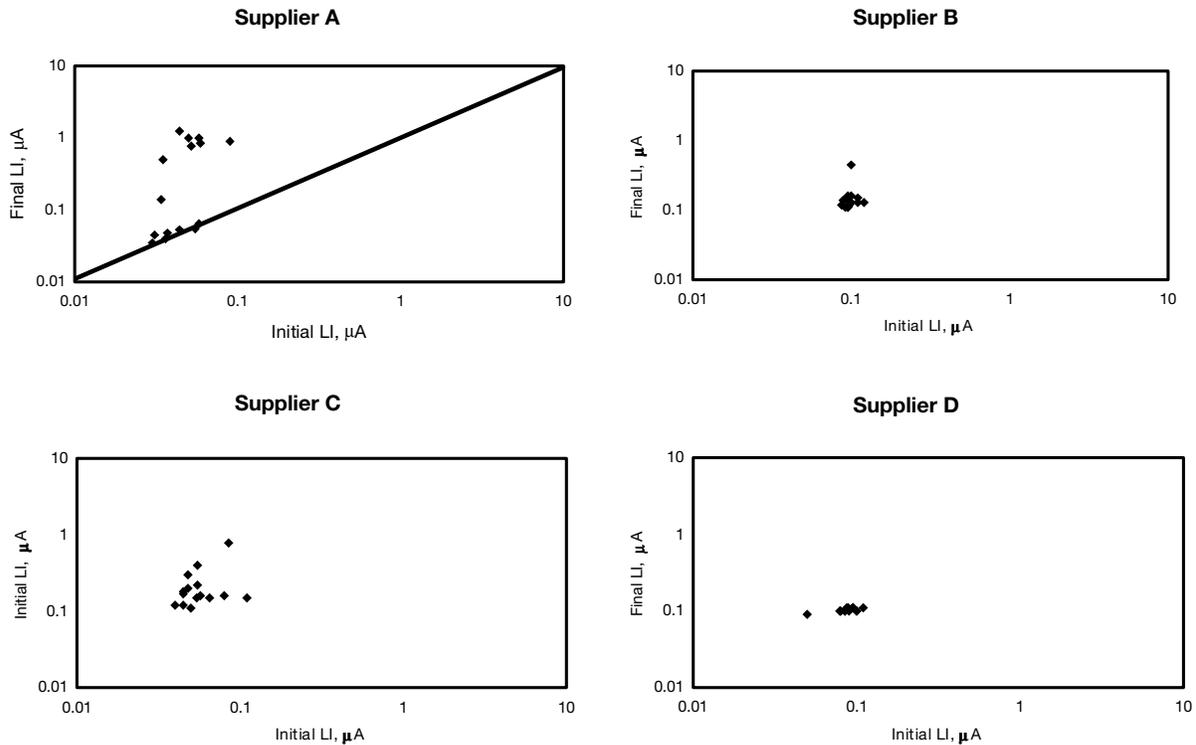
Figure 1

Some of the results of tests carried out for AVX are shown in Figure 1. This diagram shows the results from several manufacturers' 10 volt parts subjected to a 1 volt reverse bias (10% of rated voltage) for 48 hours at 85°C. The 45° sloping line on each chart is used to show a “no change” reference.

The results show that while there are some differences between manufacturers' initial leakage distributions, all experienced some increase in leakage current. They also show that for all manufacturers, parts with a low initial

leakage current were as likely to increase their leakage current as units which had a higher initial leakage current. This observation is however, similar for parts tested in the forward direction.

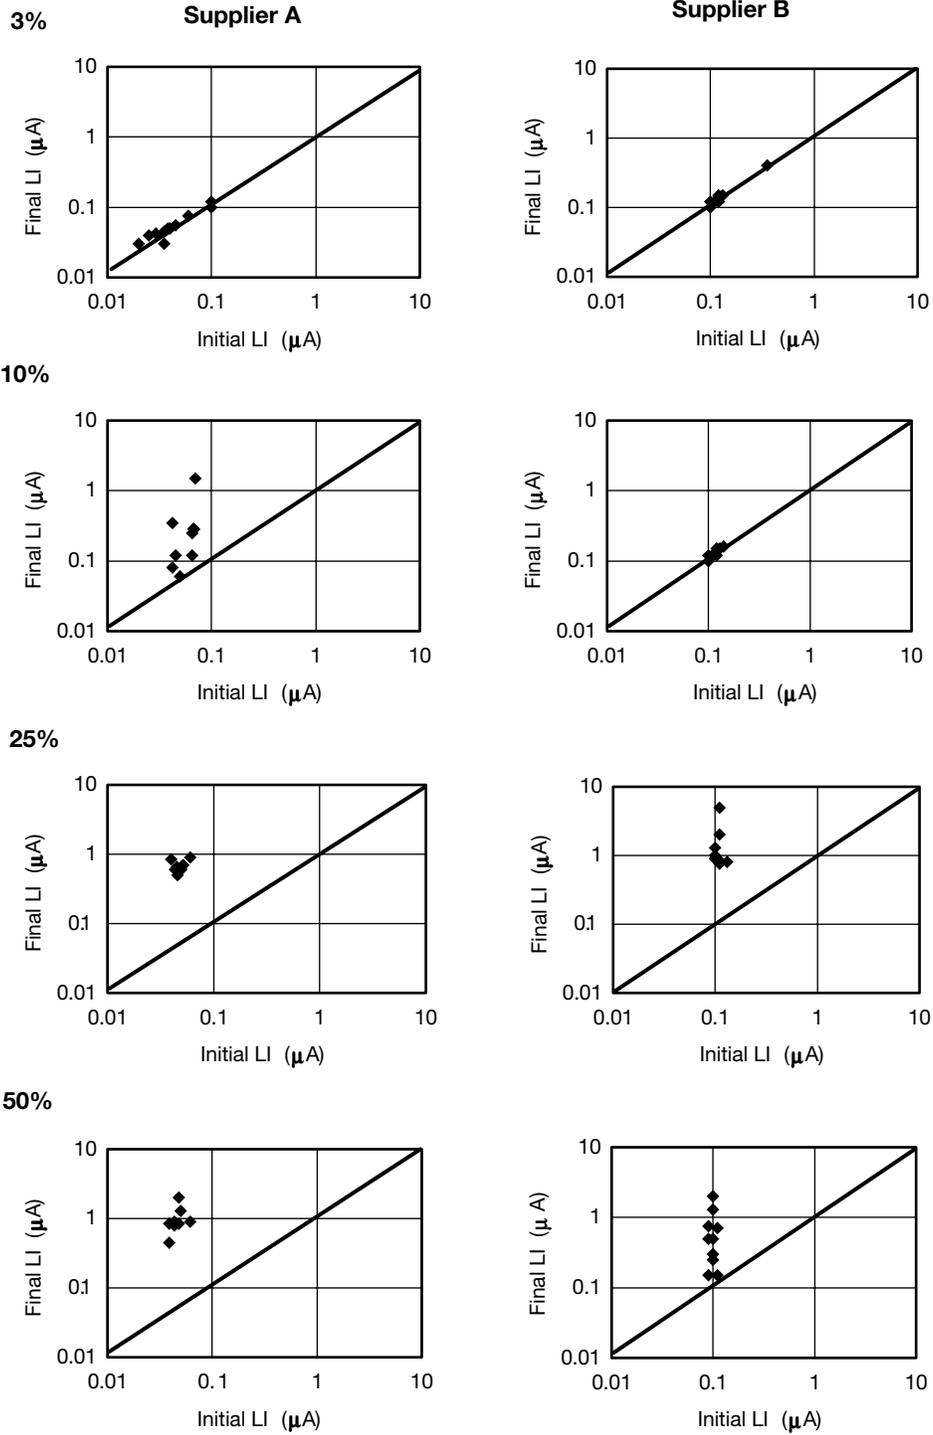
Figure 2 shows the results of experiments carried out on two manufacturers' products where the test voltage was varied from 3% to 100% of rated volts. The other test conditions were as in section 4.2. As can be seen the higher the reverse voltage applied the greater the average increase in the leakage current of the capacitor.

The table in Figure 2 indicates that at rated voltage in reverse, all the parts from two manufacturers failed, blowing the series protecting fuse.

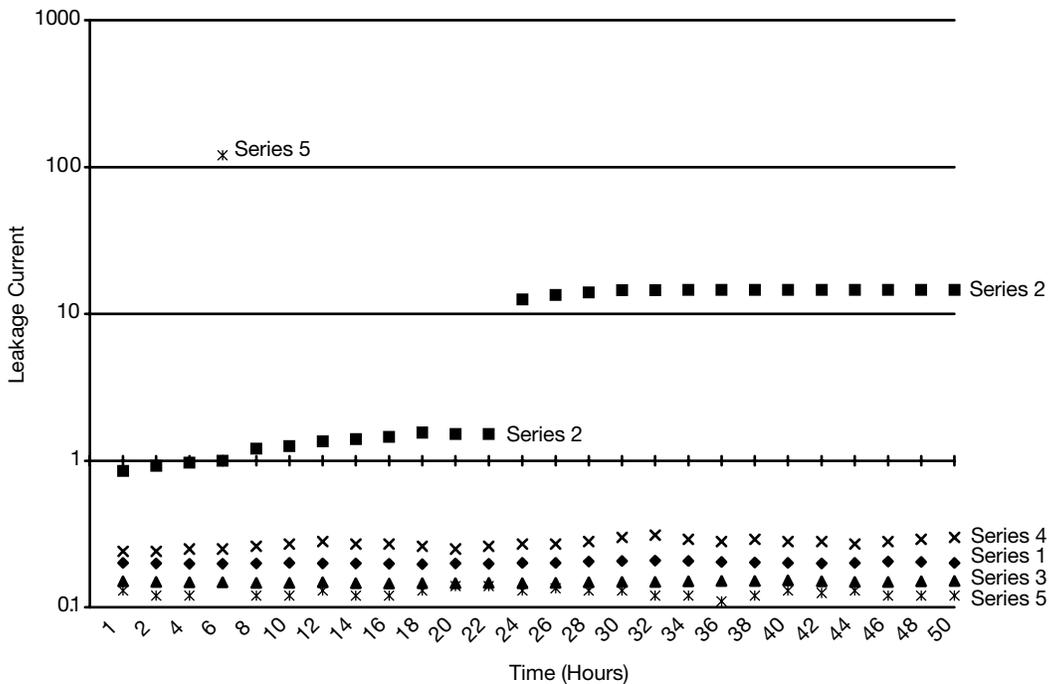
Figure 3 shows the current passing through several 10 volt tantalum capacitors subjected to a reverse bias of 1 volt at 85°C for 48 hours with an external resistance of 2.7kΩ. As can be seen, the behavior of the units varies quite considerably, with some units exhibiting a slow increase in the level of current passing, but others exhibiting sudden changes in current. Note especially the behavior of unit 5 which experienced an apparent short circuit at 10 hours

but then recovered to a more normal level.

Results have shown that this is extremely inadvisable. Application of the correct polarity to a unit which has been subjected to reverse voltage can sometimes appear to heal the capacitor, but this does not always occur as shown in section 4.4. The safest option is therefore to replace any capacitor which was connected in reverse polarity. While the majority of units recover to normal levels (see Figure 3), some units continue to exhibit abnormal behavior. Figure 4 shows the results of applying forward voltage to the units from the experiment in Figure 3 at 85°C and rated volts for 24 hours. As can be seen, unit 5 becomes very low resistance twice. If the circuit impedance were low, such a condition could result in the capacitor becoming a short circuit.

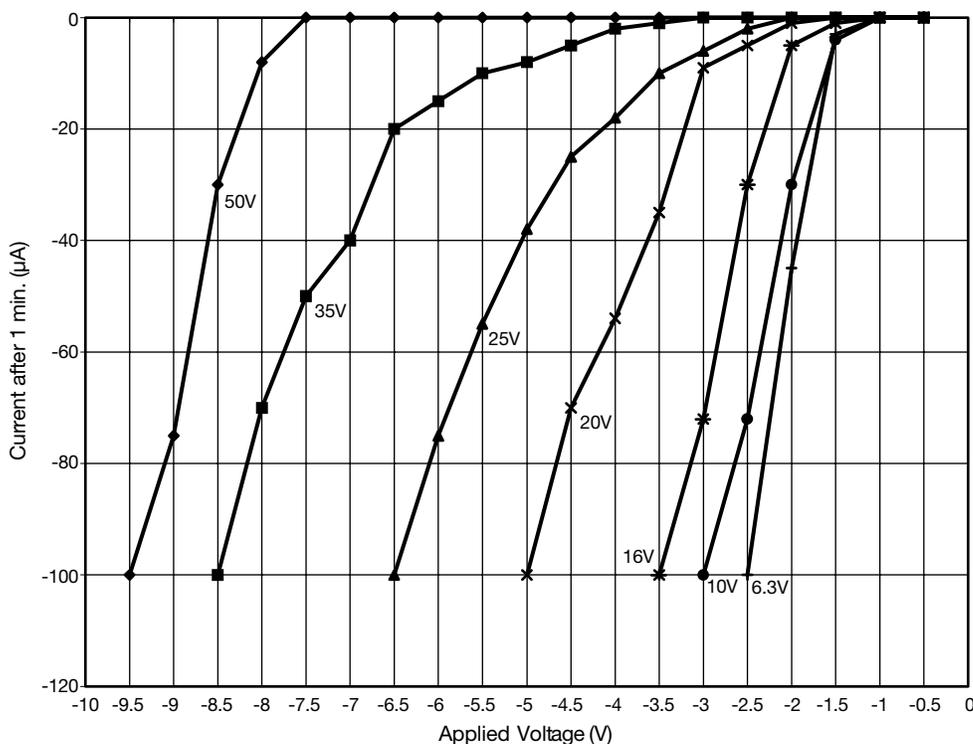
Another simple option is to use a higher voltage rated capacitor than is normally necessary. Figure 5 shows typical leakage currents for various rated capacitors under reverse voltage, and indicates that the higher the rated voltage of the capacitor, the lower the current during reverse orientation.
